TECHNICAL SERVICE BULLETIN

Bulletin Number: S-07-04

SUBJECT: 2006 - 2007 Two-Stroke IQ / Fusion Chaincase Cover Reinforcement Bracket

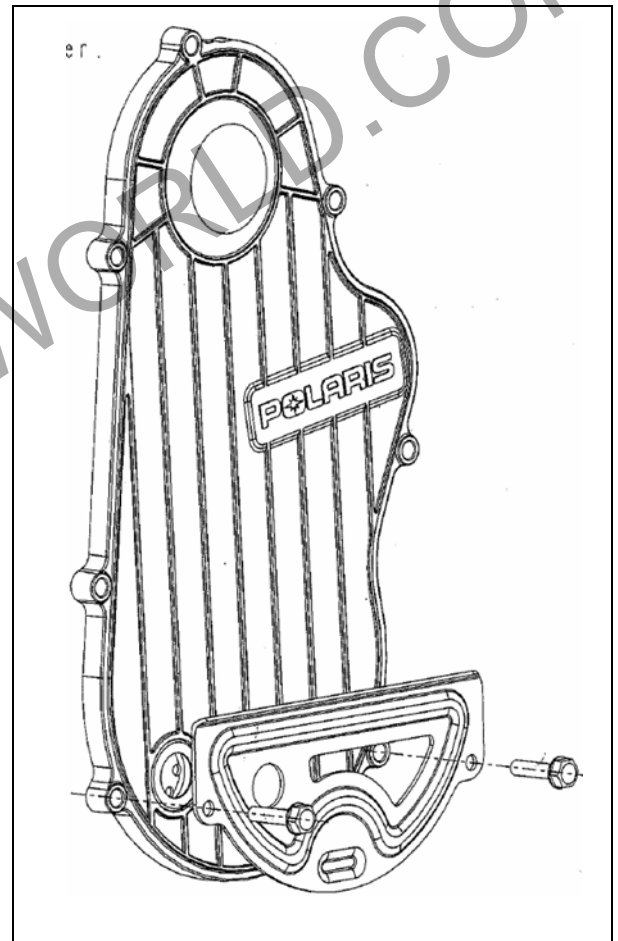
Polaris has developed a reinforcement bracket to prevent chaincase oil loss attributed to chaincase cover flexing. The bracket is designed to work on all 2006 - 2007 two-stroke IQ and Fusion model snowmobiles. *Replacing the chaincase cover before installing the reinforcement bracket is not necessary as the reinforcement bracket will keep the cover from leaking.*

1. Remove the two lower cover fasteners.
2. Install bracket as shown making sure sight glass is aligned with hole in bracket.
3. Install fasteners and torque to 10 ft.lbs. (12 Nm).
4. Verify oil level and add if required.
