TECHNICAL SERVICE BULLETIN

Snowmobile

Bulletin Number: S-07-02A
S-07-02B
S-07-02C
Model Year(s): All 2007 / Select 2006

SUBJECT: 2006 and 2007 FST Chaincase Shim Kit

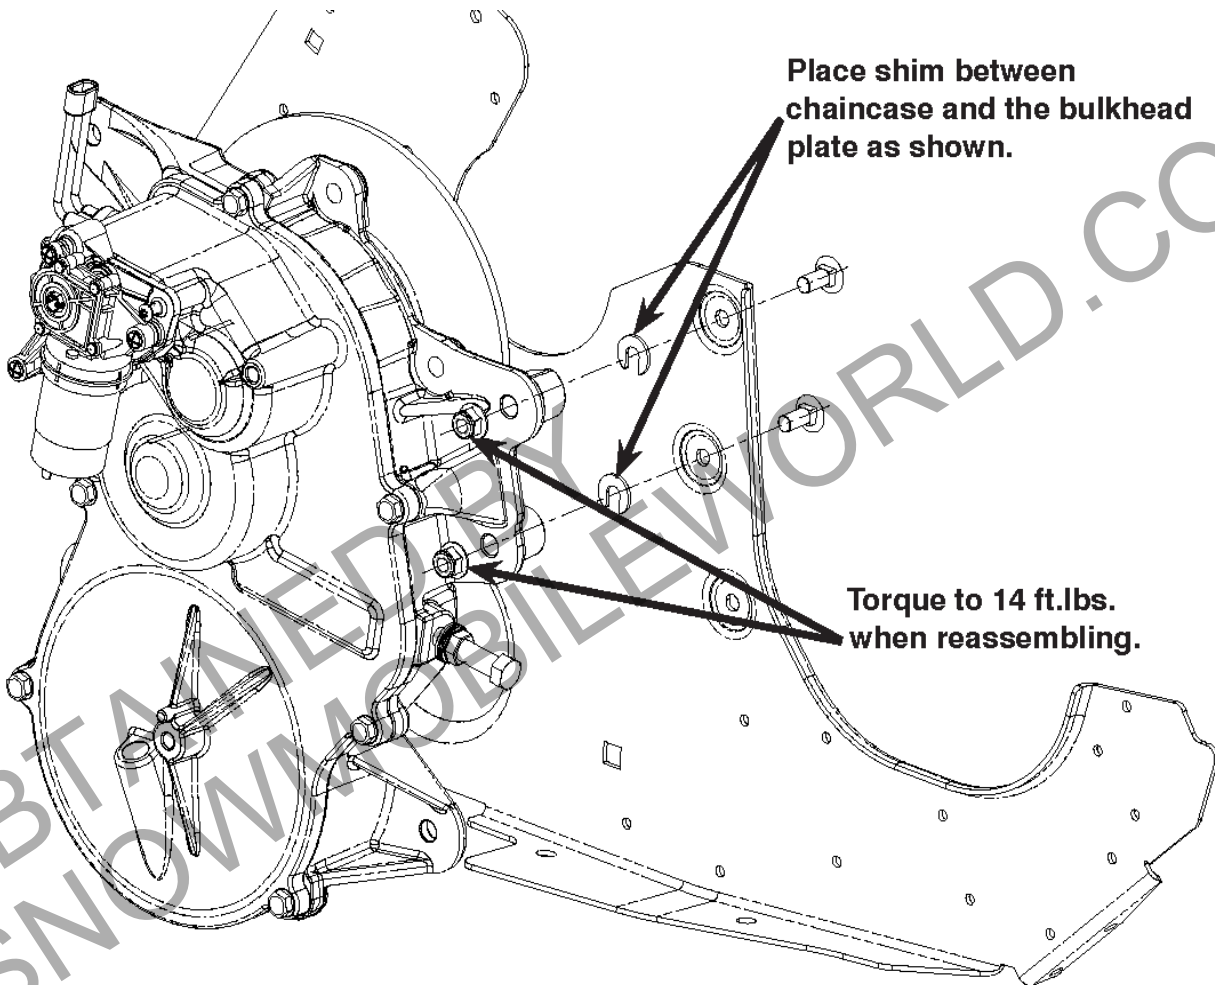
Polaris has determined the chaincase and bulkhead can become mis-aligned under load on most model year 2007 and some model year 2006 FST snowmobiles. When this occurs, the shift fork may "pop" the pinion gear off of the jackshaft thus causing the chaincase to go into a "neutral" state. To prevent this from occurring, it is recommended that the upper-right chaincase-to-bulkhead fasteners be shimmed to better align the chaincase-to-bulkhead surface. This Bulletin has a specific set of instructions for three different scenarios. In an effort to best service our customers, please read each recommendation below carefully.

1. Open the hood and remove the exhaust silencer.
2. Using a line clamp pliers, pinch off the oil tank breather hose located underneath the steering column.
3. Place a shop mat or blanket on the floor to protect the left-side of the snowmobile.
4. Rotate the snowmobile on to its left side.
5. Reference the illustration below and install the shims required to align the chaincase housing to the bulkhead panel.
6. Torque chaincase fasteners to 14 ft.lbs (19 Nm).
7. Assemble snowmobile in reverse order. Reference Service Manual for exhaust silencer fastener torque specifications and spring locations.
8. Verify the line clamp pliers has been removed from the oil tank vent hose.
